Title: MON-1 & MON-2 Wellhead Maintenance and Flow Test Report
Client: Government of Montserrat
Date: 1 June 2023
Revision: 1.0

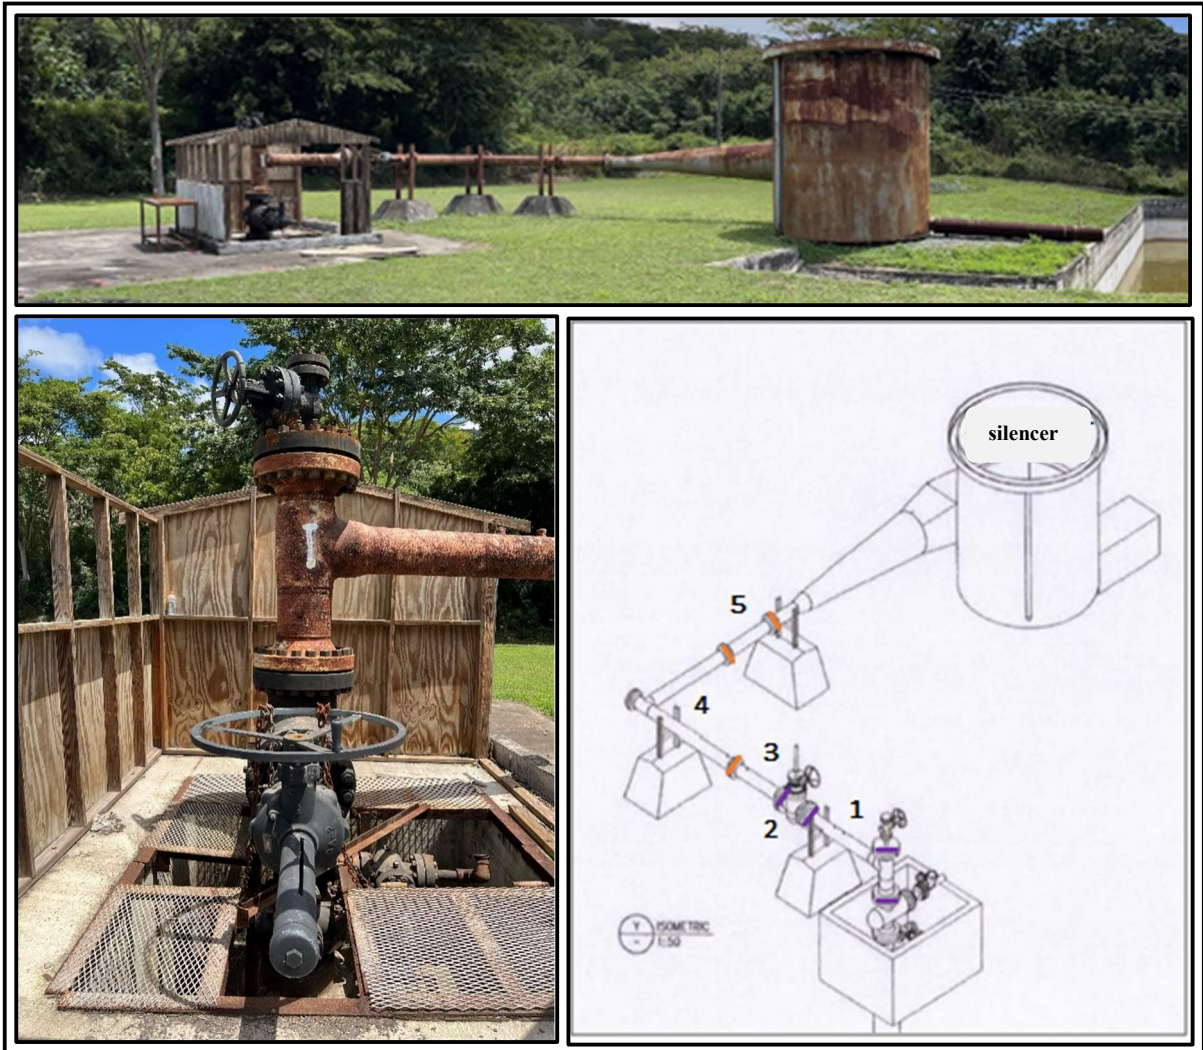
Below is a description of the well site at MON-1 prior to commencement of operations on Monday 27th March supported with photographic evidence. Note that this well site had been left set up from Phase 1 of operations in December and left unaltered.

Figure 2: Top picture shows MON-1 well site in the initial configuration 27-03-2023 / Bottom left Shows the configuration of the tree close-up on MON-1 well head / Bottom right shows the general arrangement for both MON-1 and MON-2 set up.

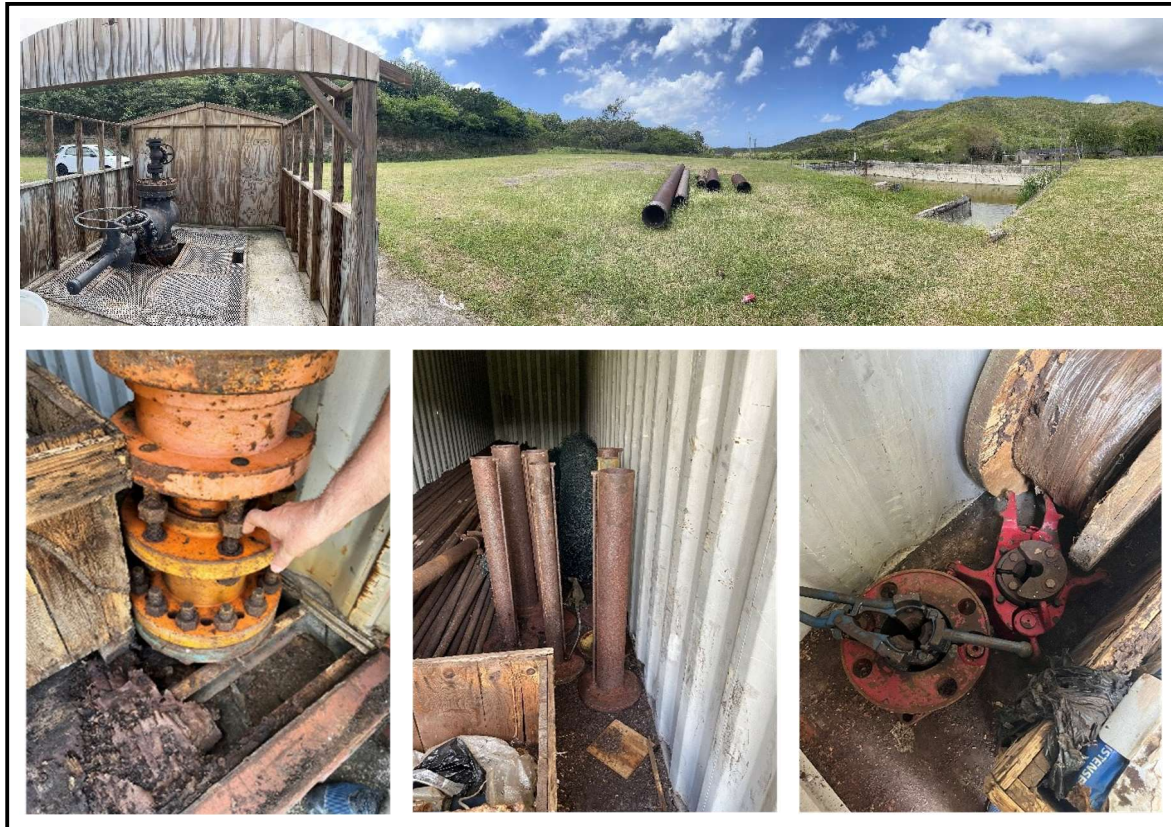
Figure 3: Pictures above show the initial condition of the MON-2 well site (top) along with the initial condition of the Giberson head (bottom left), the James Tubes (bottom centre), the slips, elevators and spare 0.092" Wire (bottom right).

As observed from Figures 3 above, the general condition of the equipment was rusty and unmaintained. Below are observations of some of the key flow-test equipment:

- Some of the bolts on the Giberson head were unserviceable at site and therefore the Giberson head could not be prepared to function fully as designed. General condition of all nuts and bolts on the Giberson head were either damaged or severely rusted.
- The general repair of the split bowl and slips were good and functioned without problem.
- The pipe was visibly rusty on the external, however, later inspection on the male and female threads showed generally good condition.
- The James Tubes were observed to be unusable with none of the spares able to take a thread to allow for an external pressure measurement at the James Tube.
- The weir box was heavily corroded with many unreparable holes rendering it unusable.

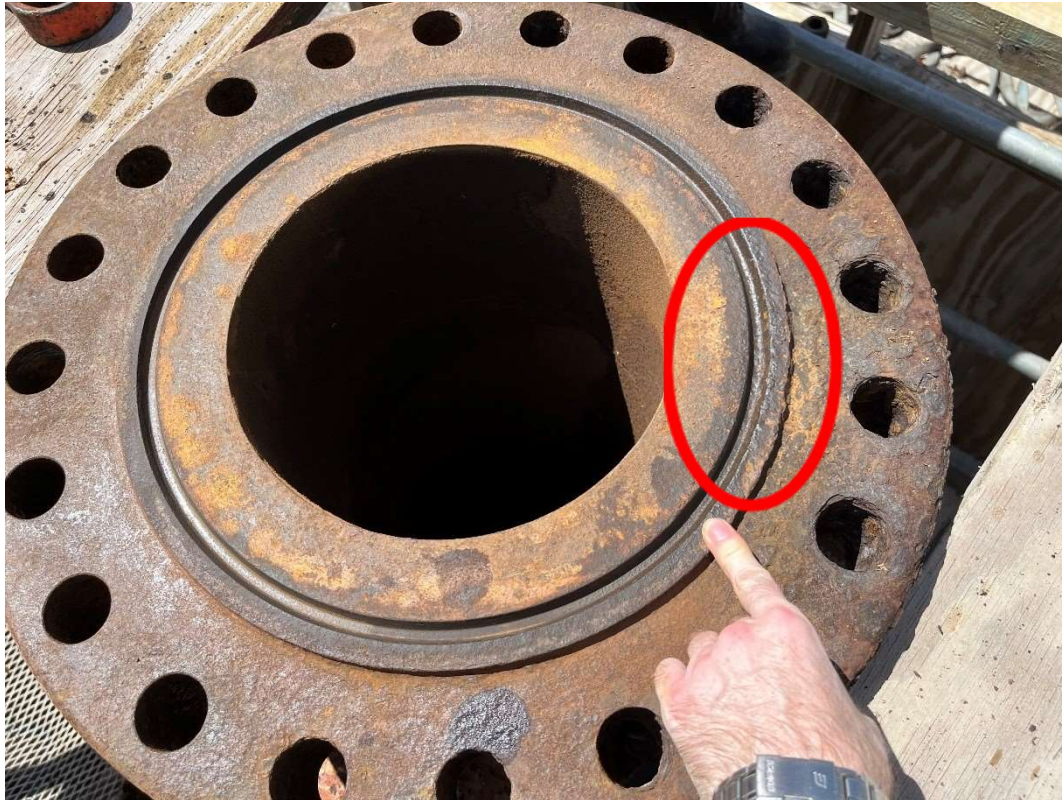
This was correctly identified as a corrosion issue on the ring gasket profile and can be seen in Figure 4 with the remedial action to insert HT silicon to enable a leak-tight seal.

Figure 4: Indicating the start of the pitting corrosion area.

The HT silicon was applied to the top connection of the Flow-T in the area shown in the picture above which carries a ring groove for a R57 gasket on the 12" AMSE/ANSI B15.5 flanged connection. Whilst the application of the HT silicon did pass the 500psi gas pressure test i.e., no visible or audible leaks, it did start to weep during the flowing period of the operation on both MON-1 & MON-2. Due to the weep being sufficiently small with no recordable H₂S, it was deemed manageable and did not necessitate a halt to operations. However, it is highly recommended to affect a more permanent repair to this piece of equipment preferably re-machining the flange face including the gasket profile. Conversely the tree cap originally attached to this face was in good condition and did not require anything more than cleaning.

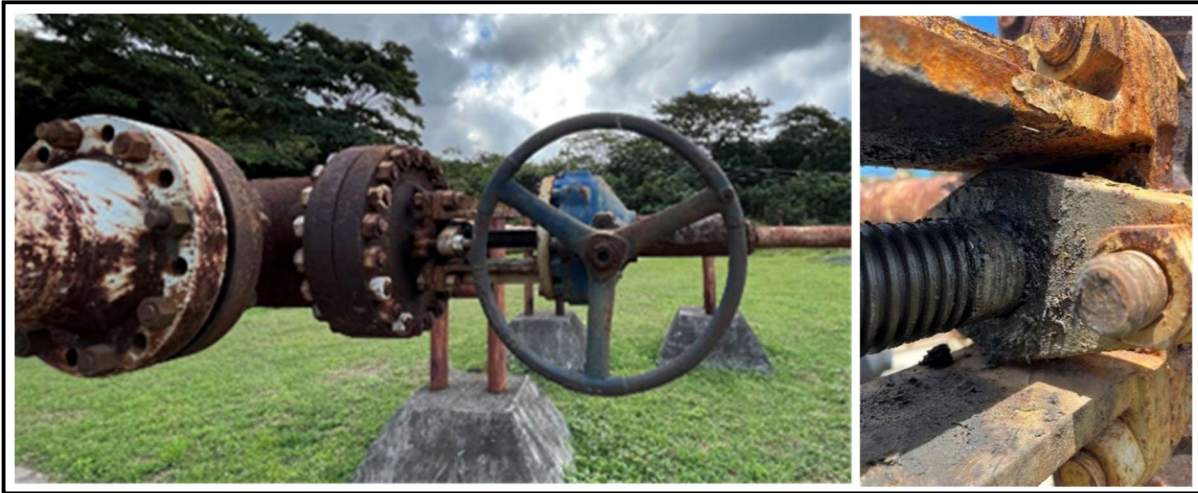
The ANSI 16.34 10" TV supplied by Delta Pacific Valves had a visible and audible leak on the steam seal packings. The plan was to affect a repair sufficient to prevent leak during the operational activities. This would have been affected by packing high-temp Teflon rope into the seal-stack cavity in behind the packing-gland and packing nut. However, on inspection the packing nut was seized to the main body of the valve, and whilst extensive attempts were made to remove the packing nut further attempts risked escalating the issue, as such it was decided to accept the leak and instead mitigate the risk of injury to personnel operating the valve.

Figure 5: 10" TV in the initial Condition (Left). View on top of packing gland where leak was emanating (Right).

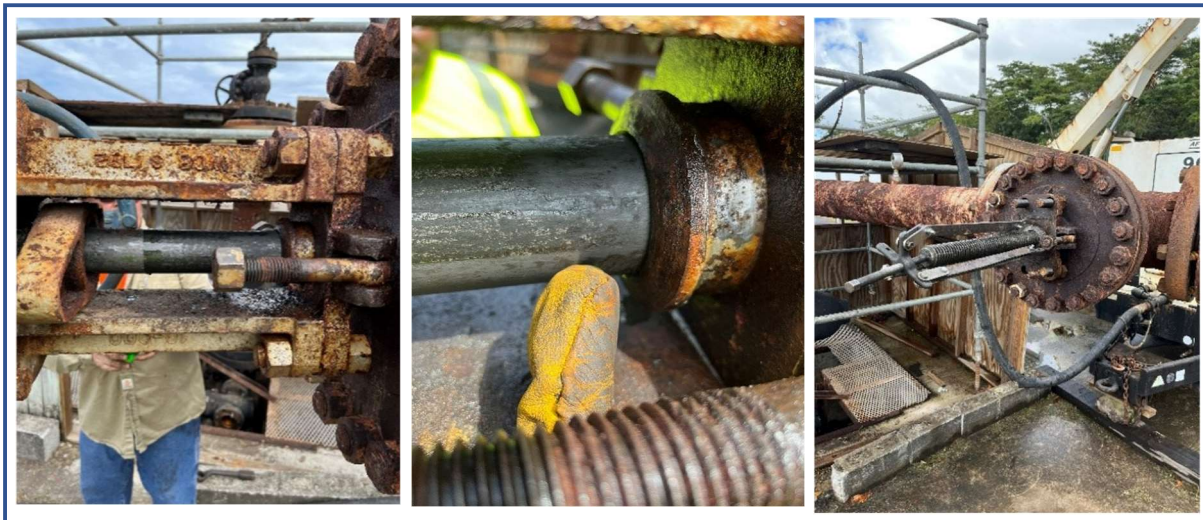
Figure 6: Side view of the stem with the packing gland retracted (Left), area where leak was emanating between packing nut and stem (centre), Attempt to retract with ceased packing nut with modified gasket removal tool (Right).

From Figure 6 above, the extent of the attempted repairs can be seen with a modified three-pronged gasket removal tool anchored on the end of the stem after removal of the gear box and valve bonnet. The modification to the three-pronged removal tool was not precise enough to allow the removal tool to extract the packing nut. This was the last attempt to gain access to the back side of the seal stack before putting in place mitigation measure to protect persons operating the throttle valve.

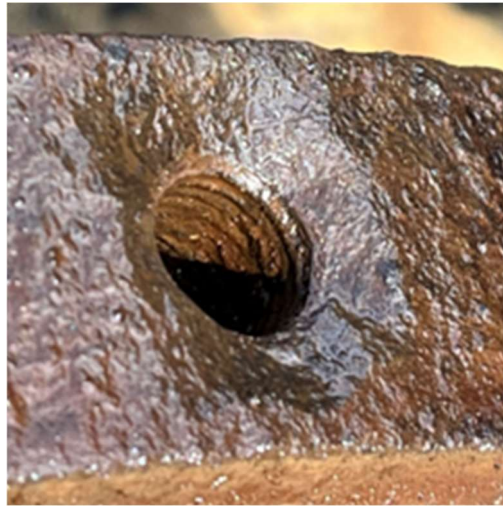
On arrival to MON-1 there was already a James Tube in place that was able to be made up to an external pressure gauge. During operations this gauge gave no useful data. The reason upon inspection after breaking out the flow line components was a broken pitot tube. On inspection of the remaining James tubes, it was impossible to clean the threads out on any of the James Tubes with the equipment at hand, see Figure 7 below as an example.

Figure 7: Indicative picture of all the threads on the spare James Tubes.

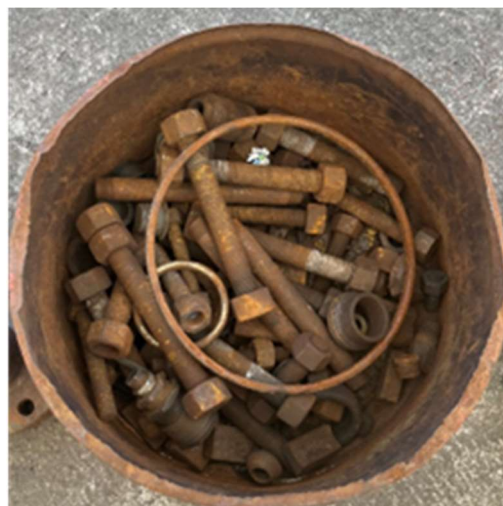
Throughout the operation there was a chronic short supply of nuts and bolts. This lack of usable parts necessitated the removing of bolts from the static well to ensure sufficient bolts were available for the critical path well.

Figure 8: Spare nuts and bolts inventory.

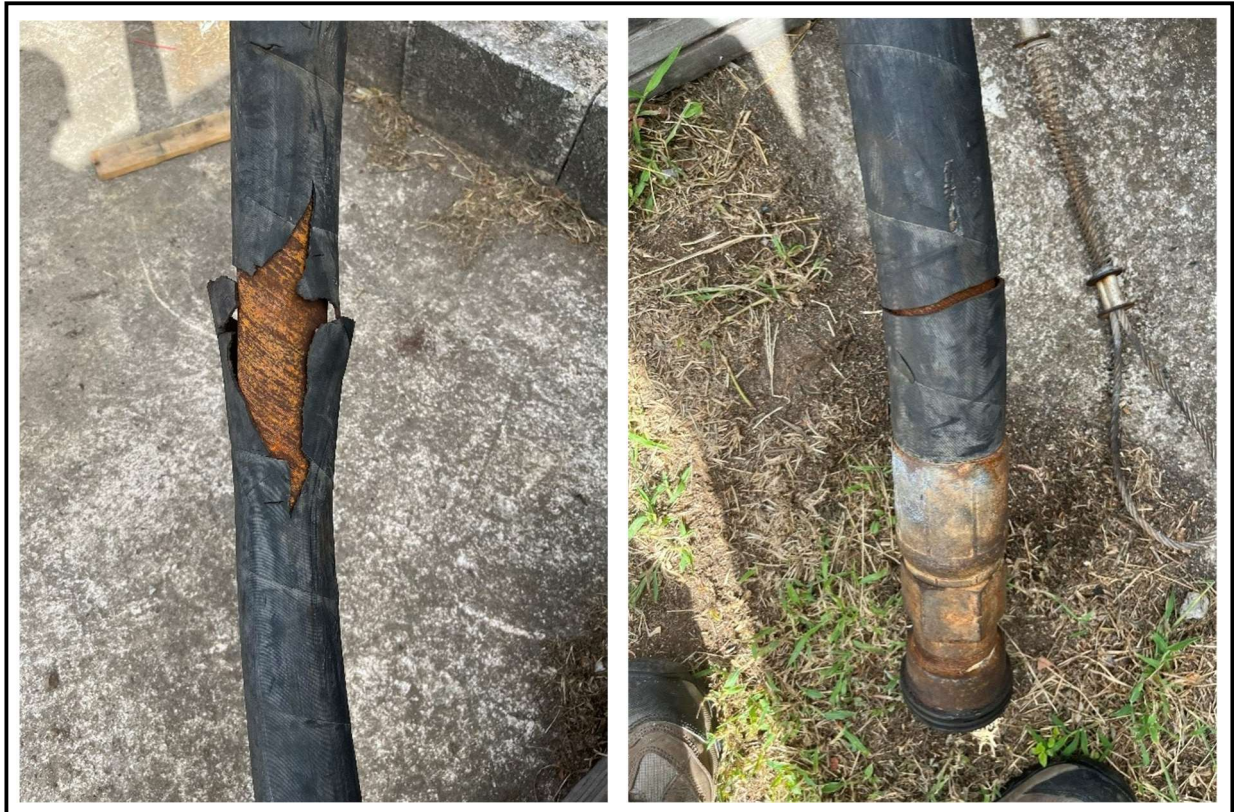
The two air hoses used to gas lift each well with 2" 1502 WECO connections were in poor condition see Figure 9 below. On pressure testing of the lines, one of the hoses showed signs of a leak through multiple layers of protection with visible bubbling on the outer rubber sleeve. This line was therefore condemned which reduced the length of hose available for use. This necessitated the need to locate the air compressor as close as possible to the well head.

Figure 9: Picture shows the visible signs of degradation of the 2x 2" 250 bar Semperit hoses.

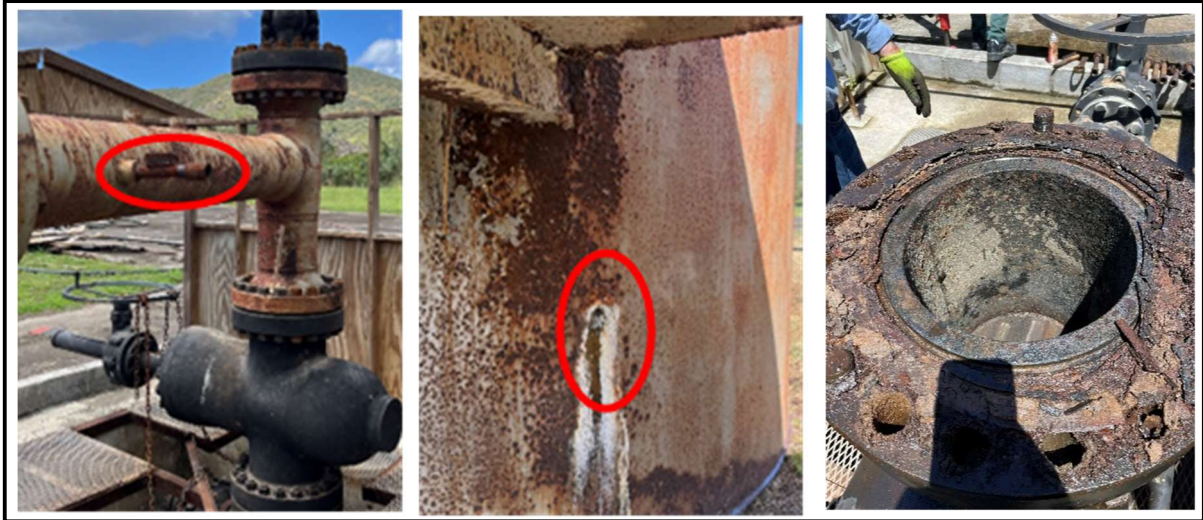
All surface flowlines to the separator are in a weathered and rusty condition. Many sealing surfaces are in particularly poor condition and need to be cleaned or even re-machined to be effective again. The most concerning was the condition of the upper flanged surface on the master valve on MON-2, which can be seen in Figure 10 below, and has a severe issue with rust between flange surfaces. Conversely the TC was in very good condition with minimal to no rust.

Figure 10: Tap point to be re-worked (Left), hole in separator requiring repair (centre), excessive corrosion on MON-2 12" master valve upper flange face (right).
