Title: MON-1 & MON-2 Wellhead Maintenance and Flow Test Report
Client: Government of Montserrat
Date: 1 June 2023
Revision: 1.0

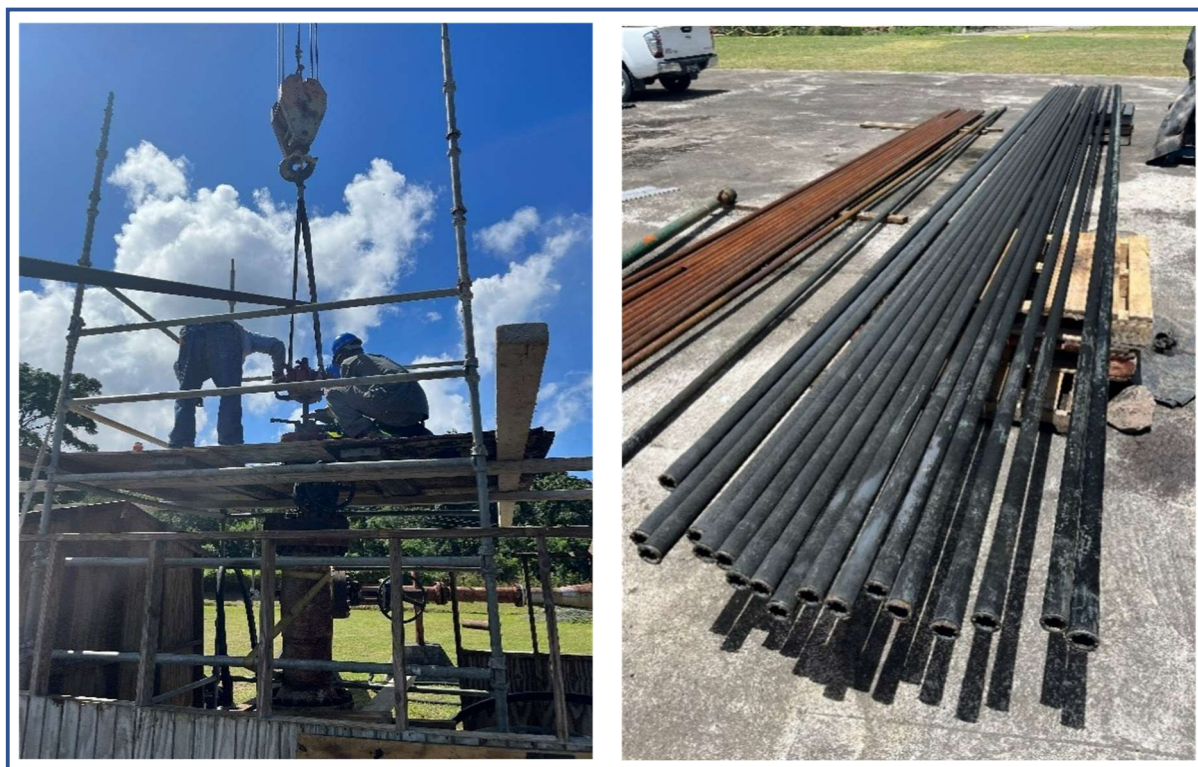
Figure 11: Above shows elevated working platform (left) and pipe rack full of recovered pipe after flowing MON-1 well (Right).

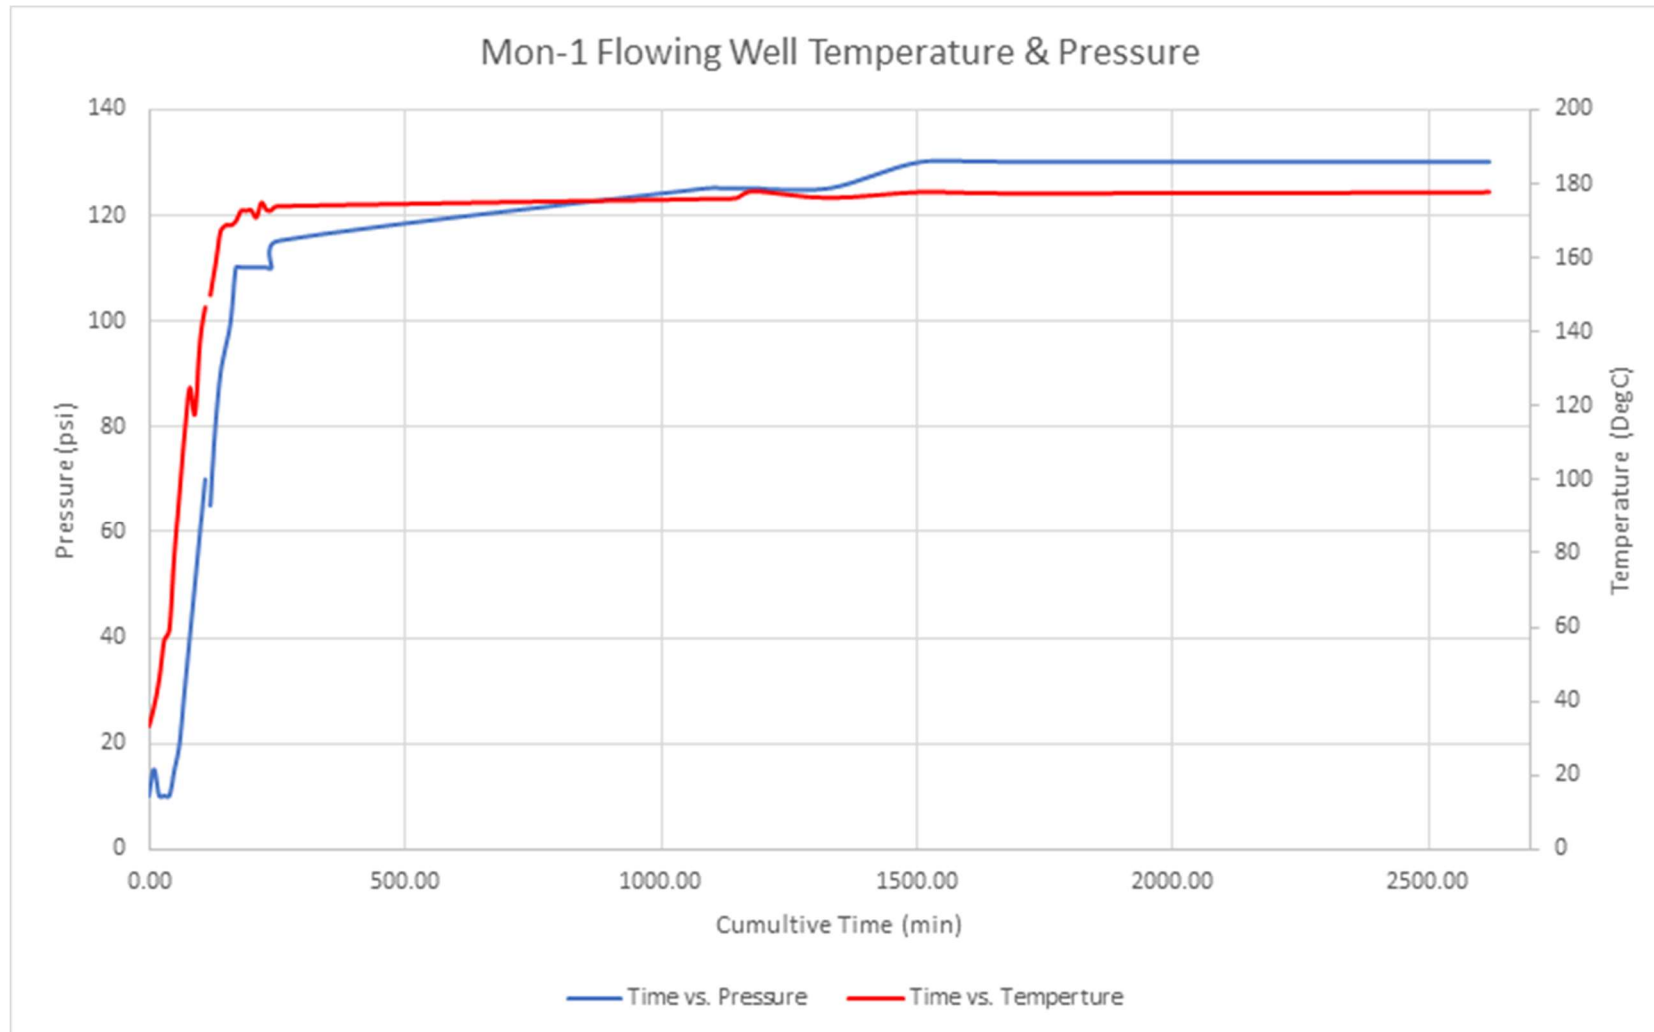
Figure 12: Pressure / Temperature vs. Time for MON-1 well flow period.

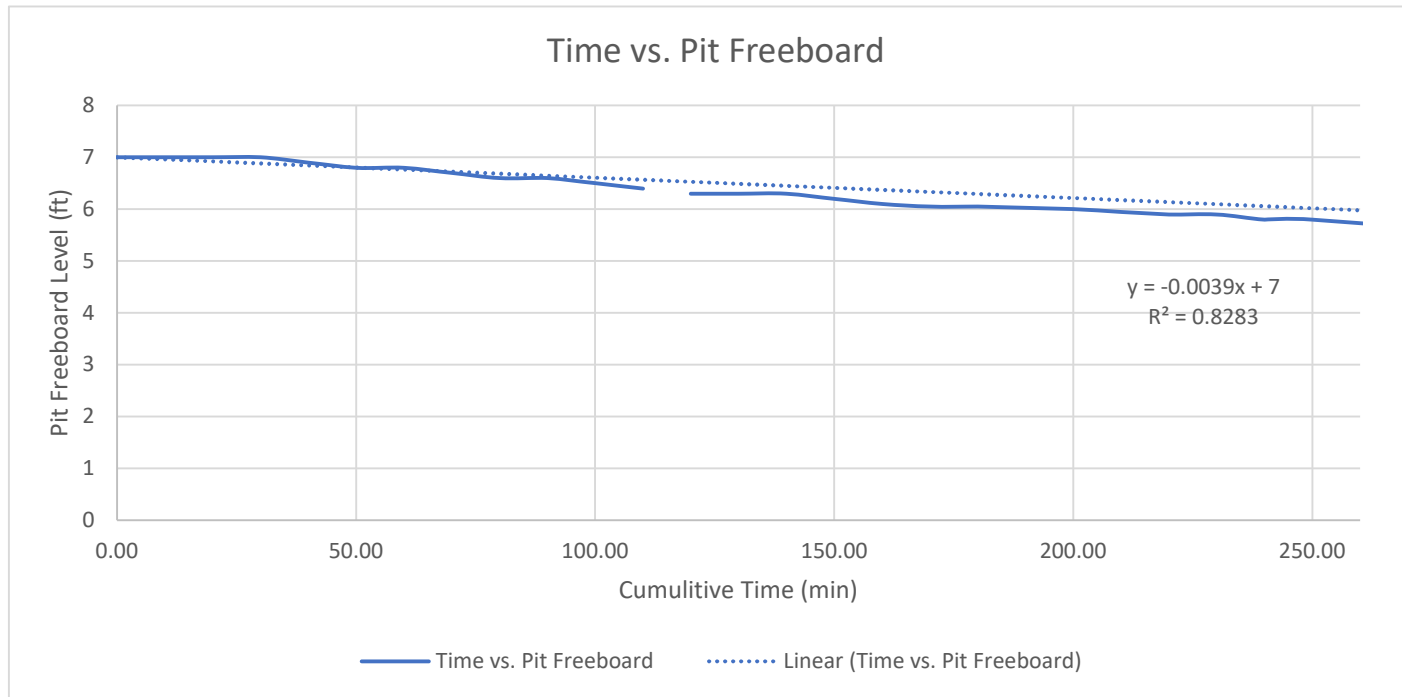
Figure 13: Pit freeboard reduction vs. time for volume fill/flow rate calculation.

From the Figure 13 above, showing the tracked reduction in freeboard on the side of the test pit, it is possible to estimate the volume fill rate over time. By plotting the freeboard height vs. time, a best fit trend line can be fitted to the results from which the equation of a line is derived as can be seen above i.e. $Y = -0.0067x + 7$. Equating this to the formula for the equation of a line $Y = mX + C$, yields, (C) as the initial starting constant (7ft), (Y) is the height of freeboard at any time (X) and (m) is the slope or rate of reduction of freeboard (-0.0039). Therefore, by multiplying the rate of reduction of freeboard by the cross-sectional area (42.5ft x 75ft) you arrive at a fill rate which in this case is:

¹ Weir box reading not available for MON-1 well. Data taken from test pit fill averaged over time details in Figure 13.

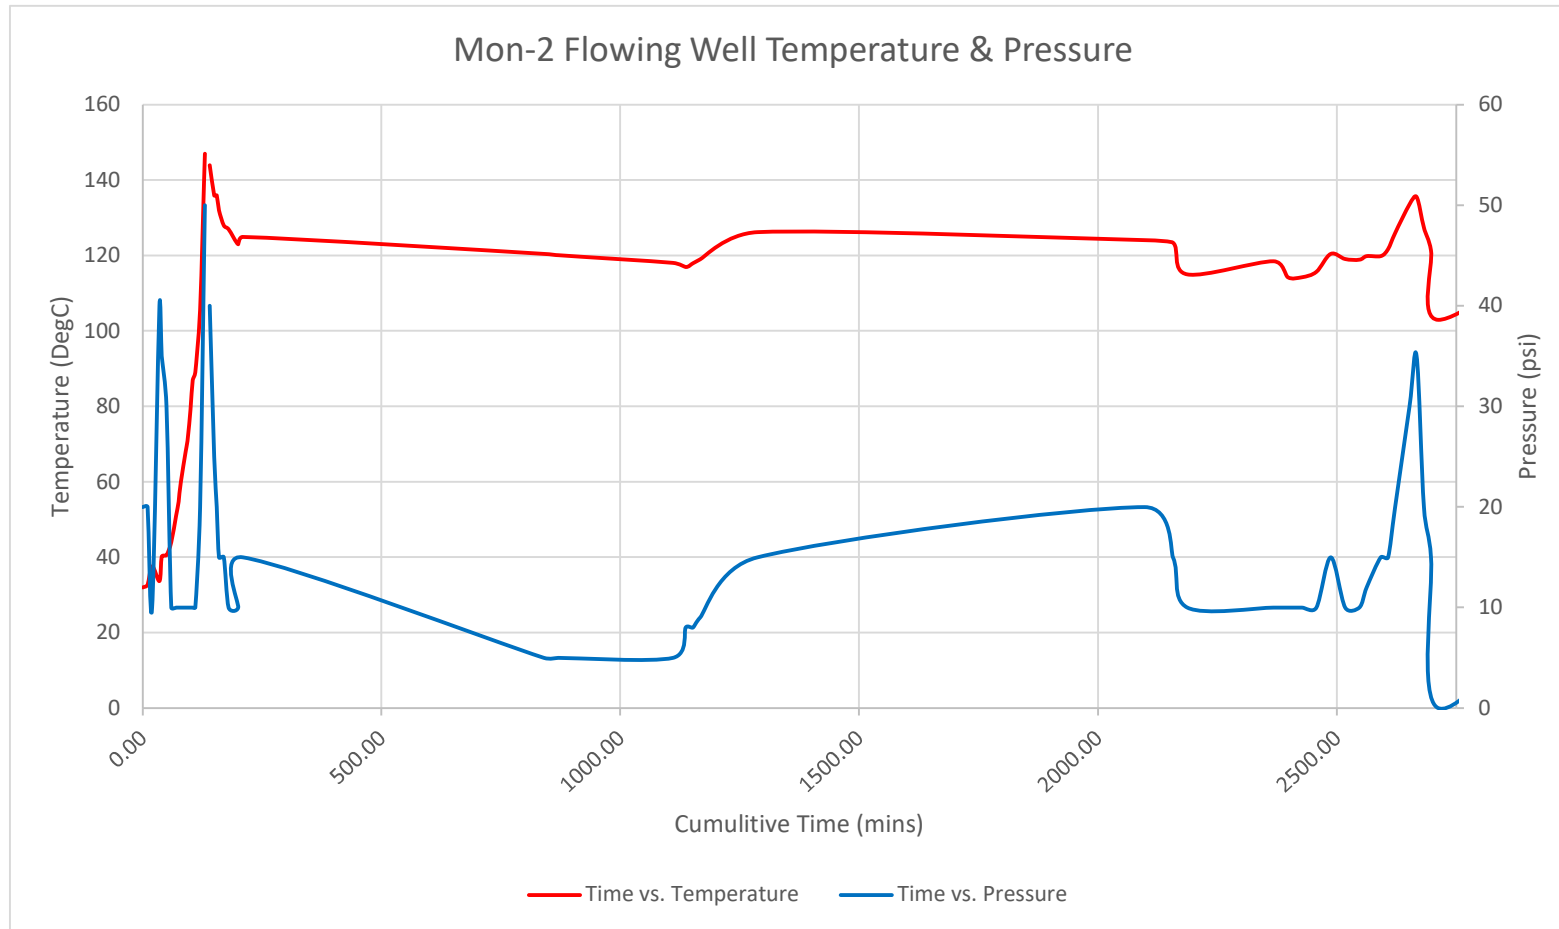
Figure 14: Pressure / Temperature vs. Time for MON-2 well flow period.

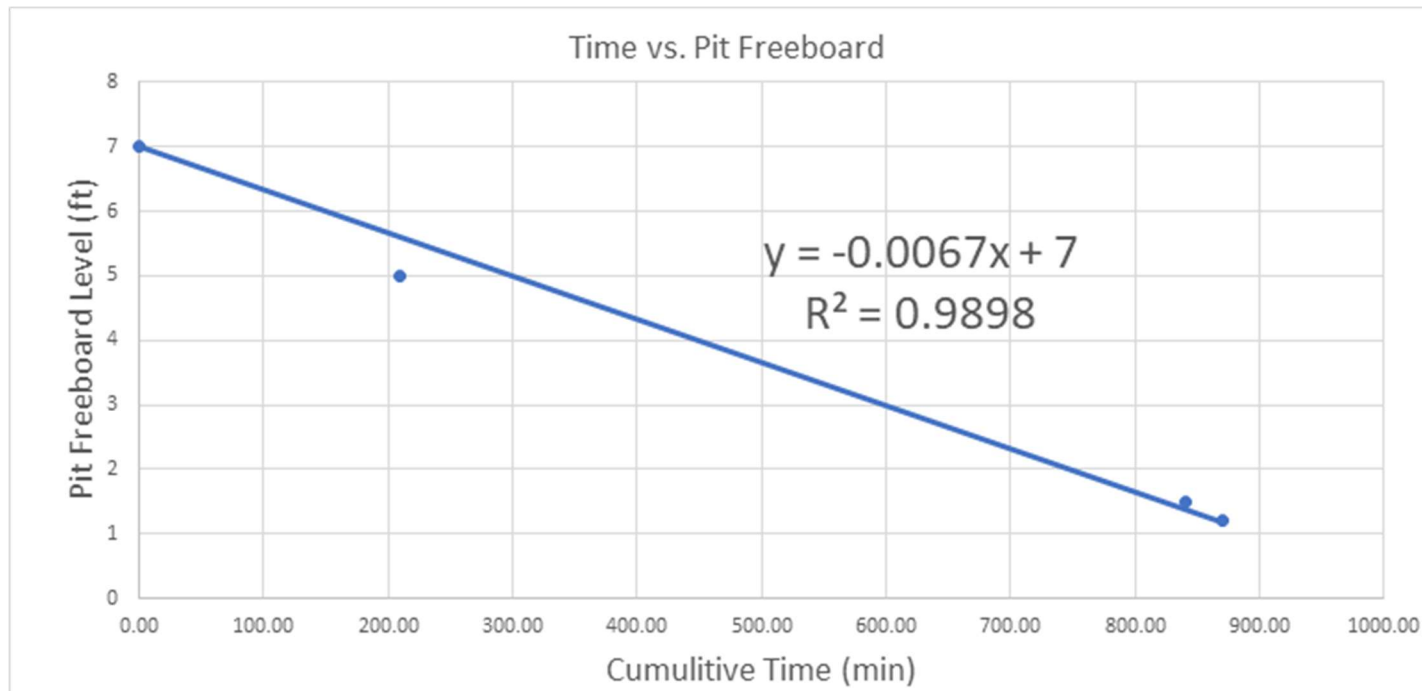
Figure 15: Pit freeboard reduction vs. time for volume fill/flow rate calculation.

From Figure 15 above, showing the tracked reduction in freeboard on the side of the test pit, it is possible to estimate the volume fill rate over time. By plotting the freeboard height vs. time, a best fit trend line can be fitted to the results from which the equation of a line is derived as can be seen above i.e. $Y = -0.0067x + 7$. Equating this to the formula for the equation of a line $Y = mX + C$, yields, (C) as the initial starting constant (7ft), (Y) is the height of freeboard at any time (X) and (m) is the slope or rate of decay of freeboard (-0.0067). Therefore, by multiplying the rate of reduction of freeboard by the cross-sectional area (42.5ft x 80ft) you arrive at a fill rate which in this case is:

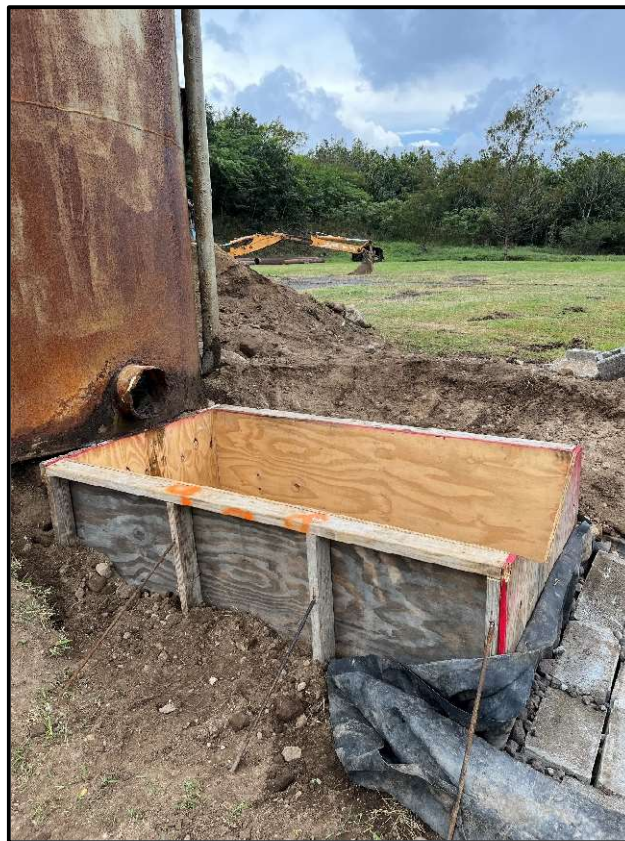
Figure 16: Weir box set up in place on outlet of separator. The weir box measured 79" x 40" x 40" with a 120 degree V-notch weir extending to each side with the point of the V-notch 29" up from the bottom
